# Petra Diamonds Limited (Petra)

## GISTM tailings facility disclosure

### Cullinan Diamond Mine No. 7 Dam

GISTM consequence classification: Extreme

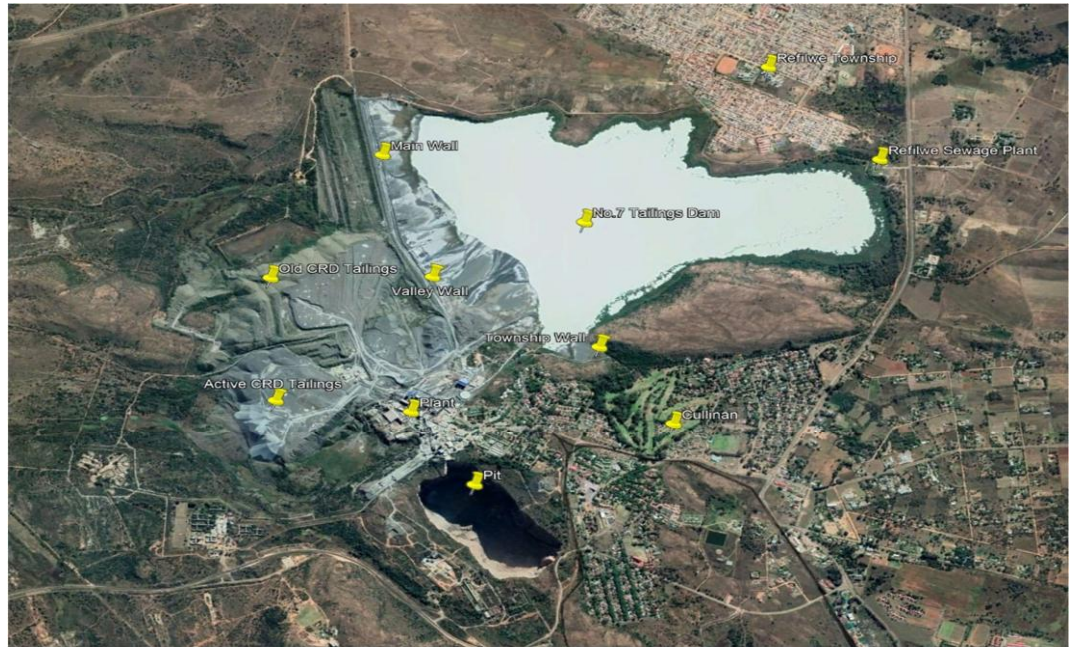
Figure 1-1: Mine Layout

- 1.1. The Cullinan Diamond Mine (the Cullinan Mine or the Mine) is located in the town of Cullinan, 46.2km north of Pretoria in the Gauteng Province. Figure 1-1 below shows the location of the Mine and the location of the mine residue facilities. CDM is operated by an indirectly owned subsidiary of Petra, Cullinan Diamond Mine (Pty) Limited (CDM).

5. History and description of the Cullinan Diamond Mine No. 7 dam facility
- 5.1. Construction of the Facility started in 1957 as part of the mining activities. The Facility is constructed in a valley with three impoundment walls containing the mine residue and water in the basin. The impoundment walls are known as the Main Wall, the Valley Wall and the Township Wall (as shown in Figure 1-1).
